Navajo Abandoned Uranium Mine

Site Screen Report

Key and Tohe AUM Site

March 2010

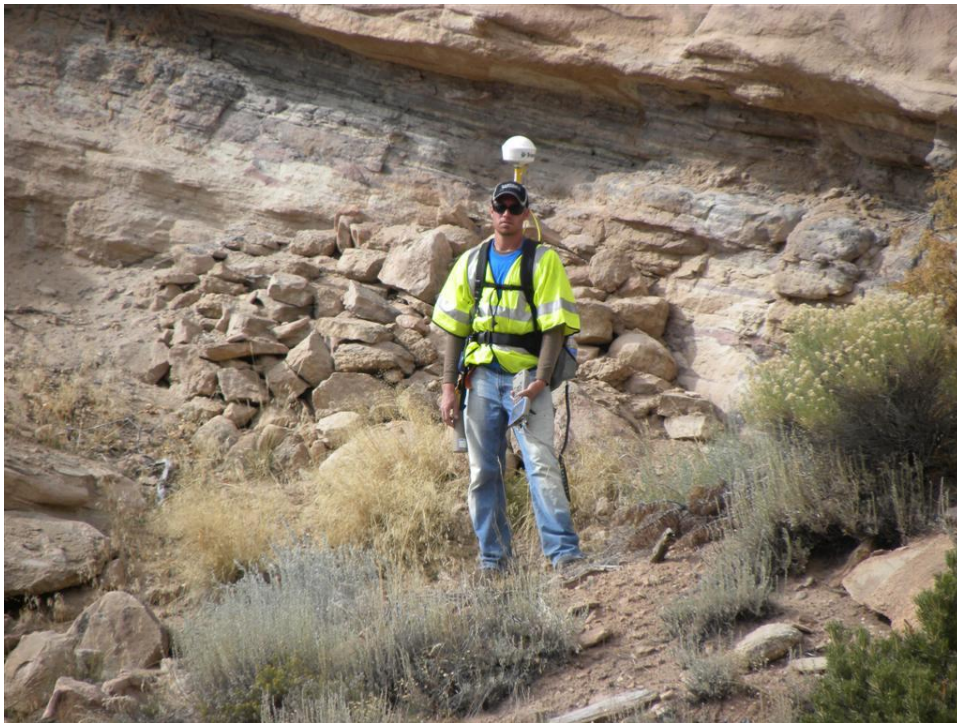
2 stone sealed adits above the ravine

Photo 2. Sealed adit (east)

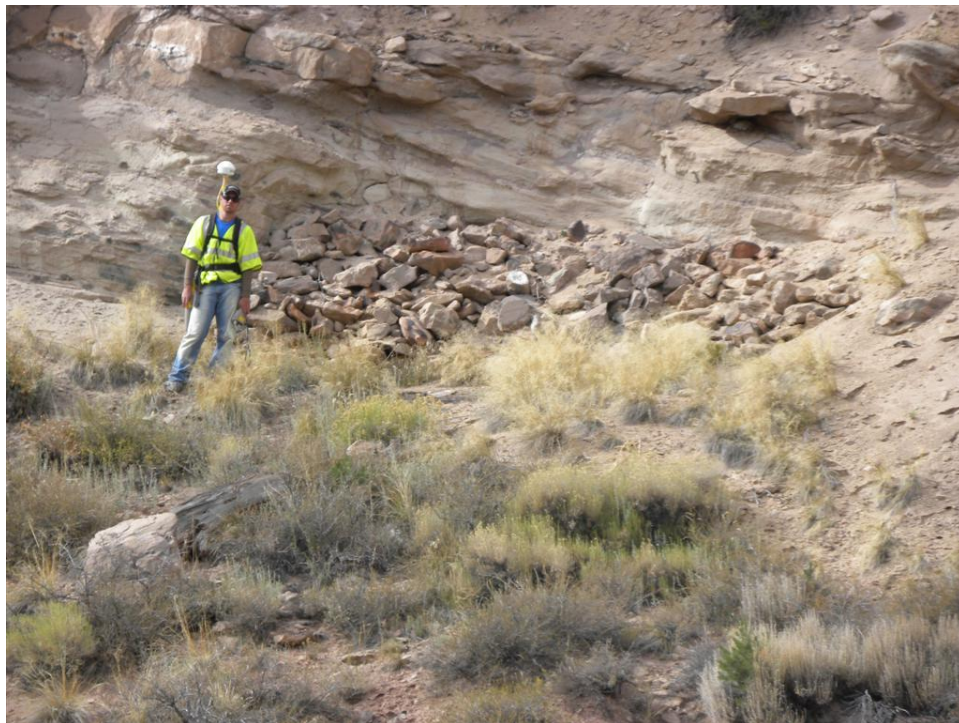
Photo 3. Sealed adit (west)

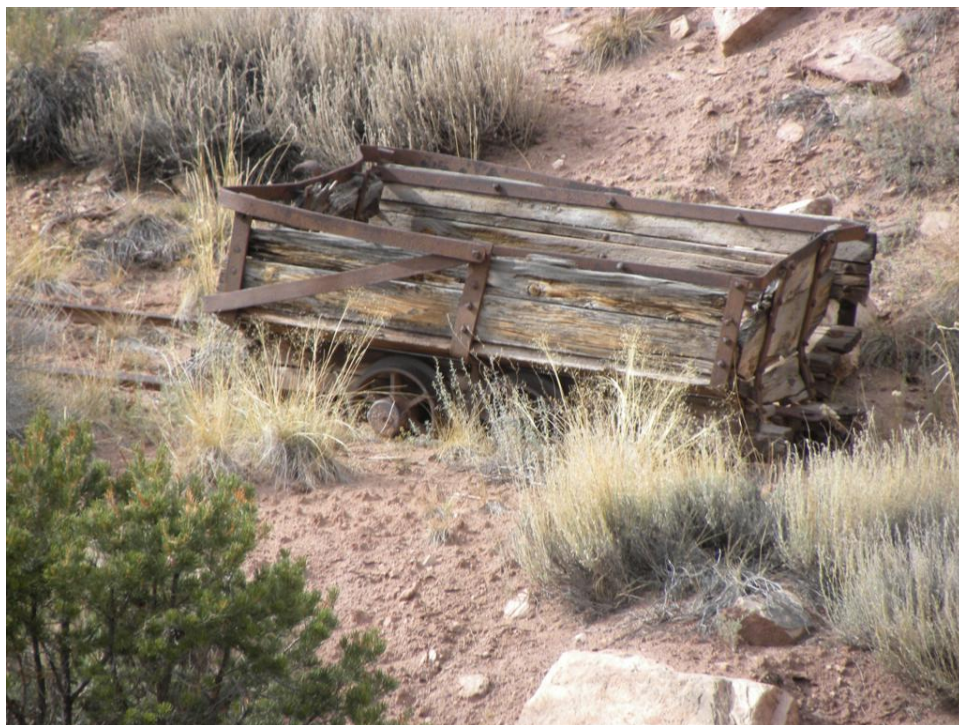
Various wood and metal mining debris, including carts, rails, and pipes

Photo 4. Mining cart

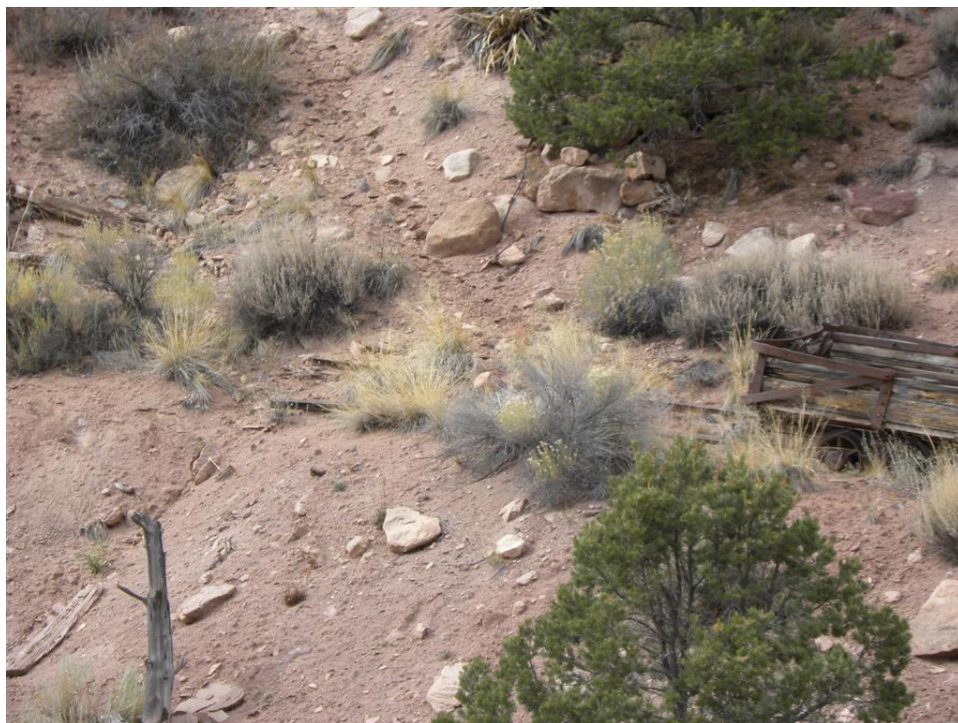
Photo 5. Mining and waste debris
